HUNTERS POINT SHIPYARD
PARCEL E EMERGENCY REMOVAL ACTION
LANDFILL GAS CONTROL SYSTEM

TUESDAY 18, SEPTEMBER 2002
DAILY ENGINEER'S REPORT

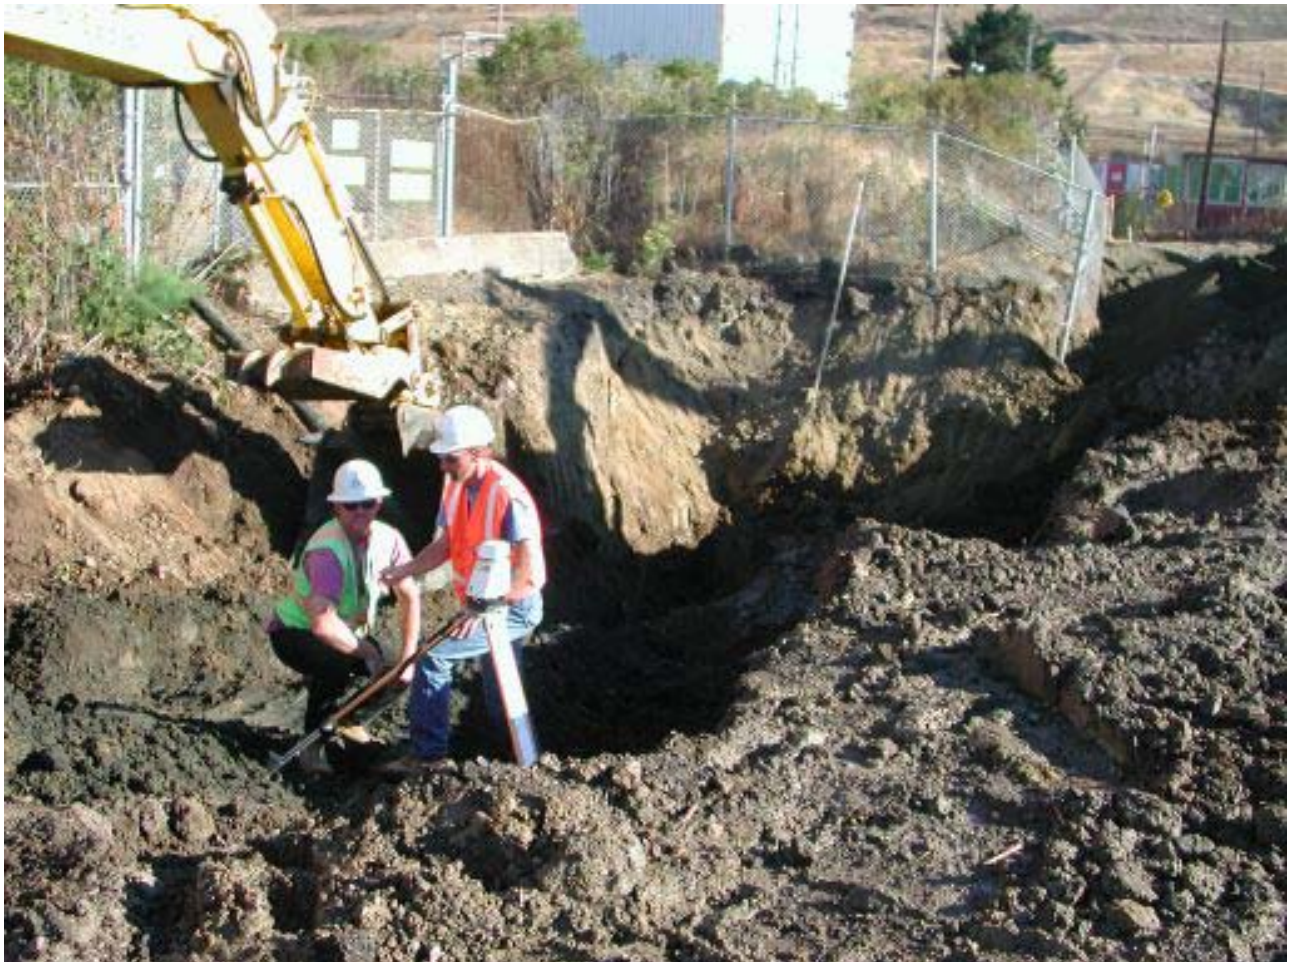
- Tailgate health and safety meeting.
- Started excavation in NW corner to removed large pieces of concrete discovered previously. Excavated through BART soil down to top of concrete. Stopped and determined elevations using survey equipment. The top of concrete was determined to be between elevation 0.0 and 1.0, which was already below the design depth of the wall. In addition, groundwater appeared to be entering the trench 1.5 feet above the top of the concrete. The decision was made to leave the concrete in place and backfill. Continued trenching and discovered a 10" steel line approximately 10 feet below grade at STA 14+66. Steve Tyahla called the CSO and determined that this line did not show up on their utility drawings. Charles Mazowiecki and Steve DelHomme met the neighbor (Ted Dawes or Dawson) who occupies the Navy property along that fence line. He stated that he had been there since the 1930s and that there were no water lines or sewer lines that ever extended that far. He said it may be either a piece of pipe thrown in the ground or an old drainage line that was now abandoned. He noted that raw sewage used to flow through a pipe into the bay at that point. He also mentioned that the Navy property line was 90 feet from the building immediately to the west. He had built the foundations and filled that area himself and he noted that there were huge pieces of concrete along the old shoreline similar to those excavated for the trench, but that he had never seen any waste outside of the fence line and that he had used clean fill on that side of the fence when raising the grade. The decision was made to try to move the pipe with the excavator. The pipe cracked slightly and was not under pressure, so the excavator was used to break the line and remove it. The line was empty, but appeared to contain remnants of sludge or bunker oil in the bottom. The line remaining in the ground was plugged with BART soil and the excavation was backfilled. This completed the excavation operation for trench clearing.

Photograph 1. Measuring the depth of concrete (approx. top elevation 0.5) Left in place.

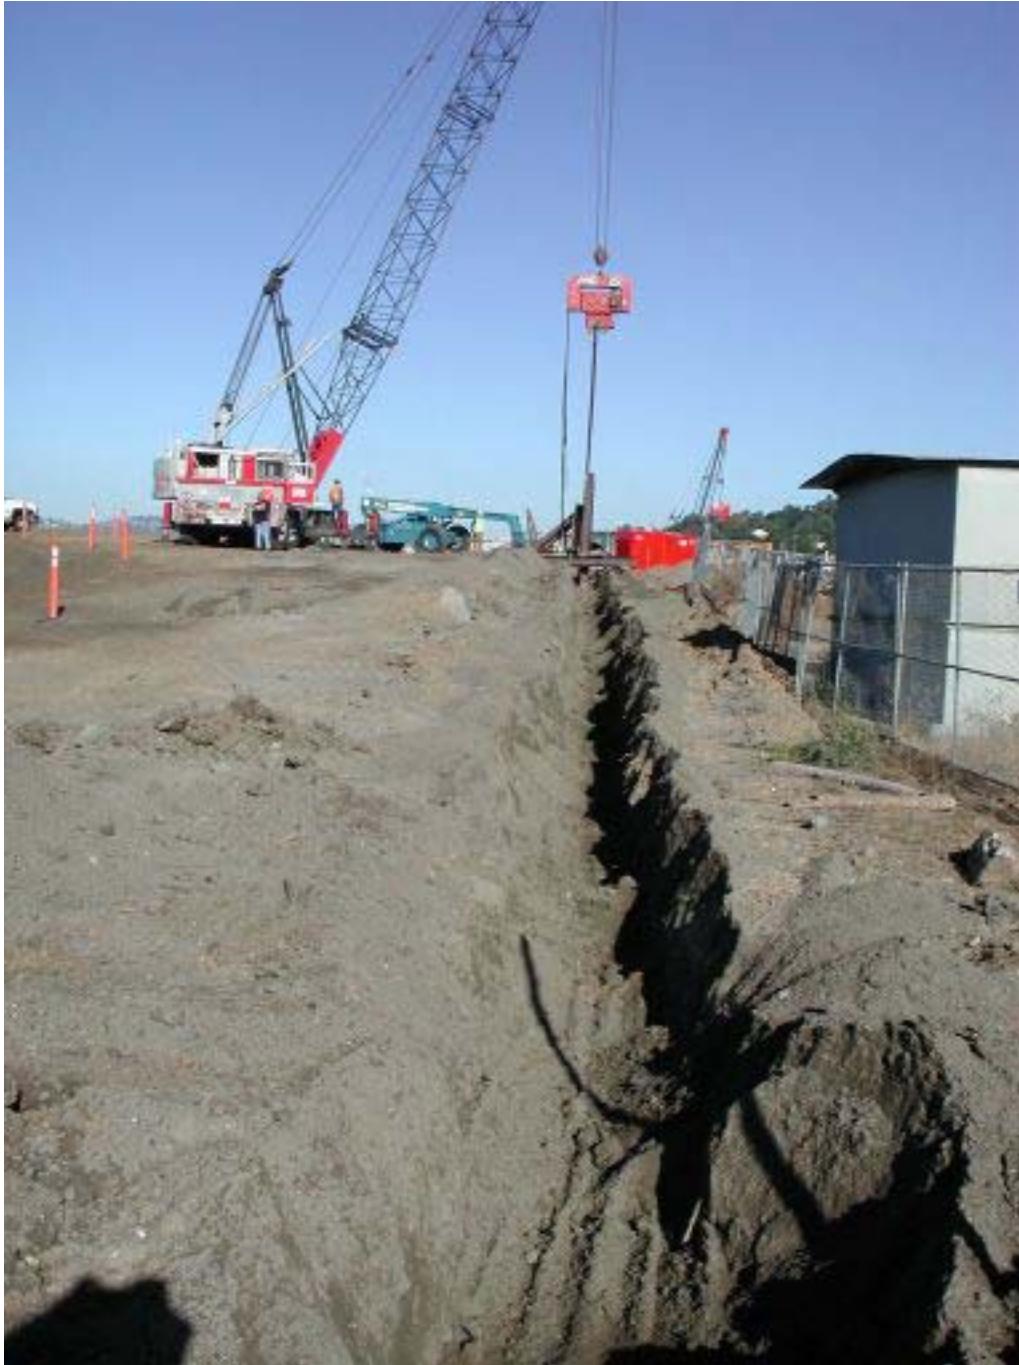
- Excavated 135 cy of soil from trenching operations of which 135 cy were stockpiled as reusable soil for fill.
- Continued installation Gundwall. No obstructions or refusals were encountered. However, the seam came apart on the Gundwall at STA 2+03. Cooper Crane tried to drive a second sheet, but the and both sheets had to be removed with the excavator. When removing the mandrel after excavation a rock apparently fell between the mandrel and the sheet and cut the sheet. There are presently cuts in the sheets at Stations 2+03 and 1+95. Cooper Crane will get an extrusion welder to seal the cuts prior to backfilling.

Photograph 2. Installation of Gundwall with 65-ton crane STA 2+00.

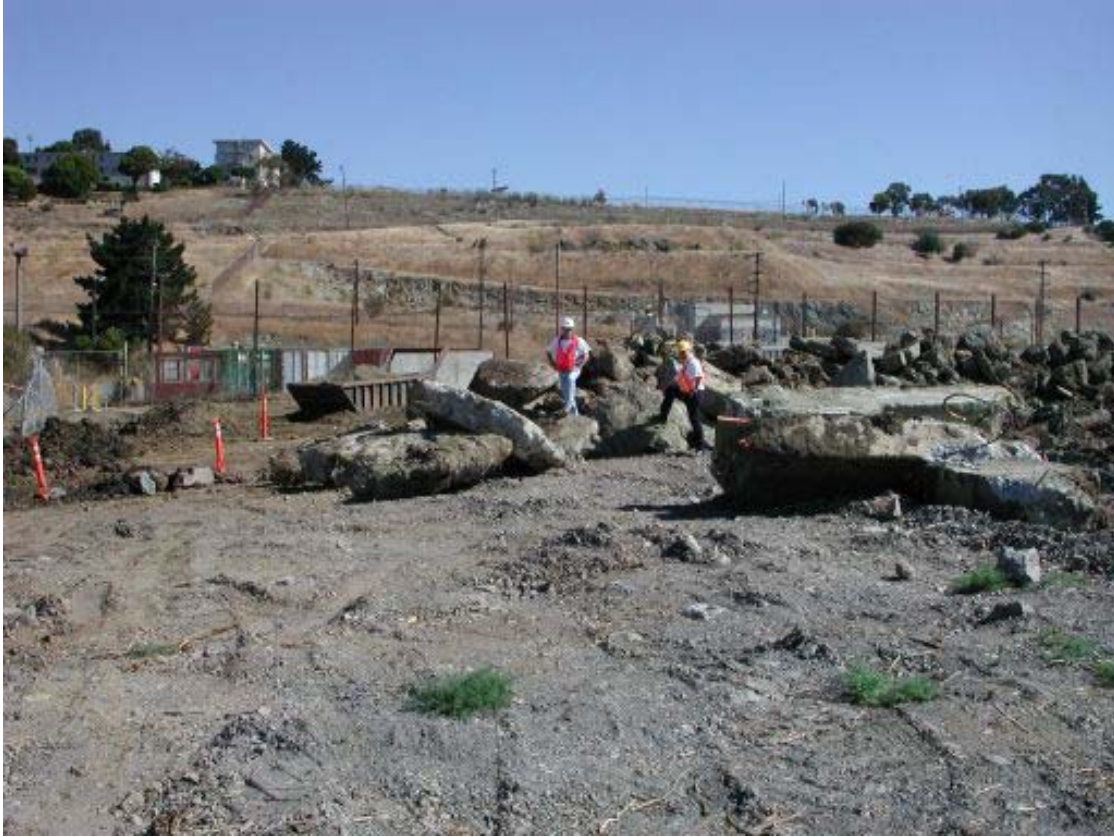
Photograph 3. Final concrete debris stockpile from trench installation.

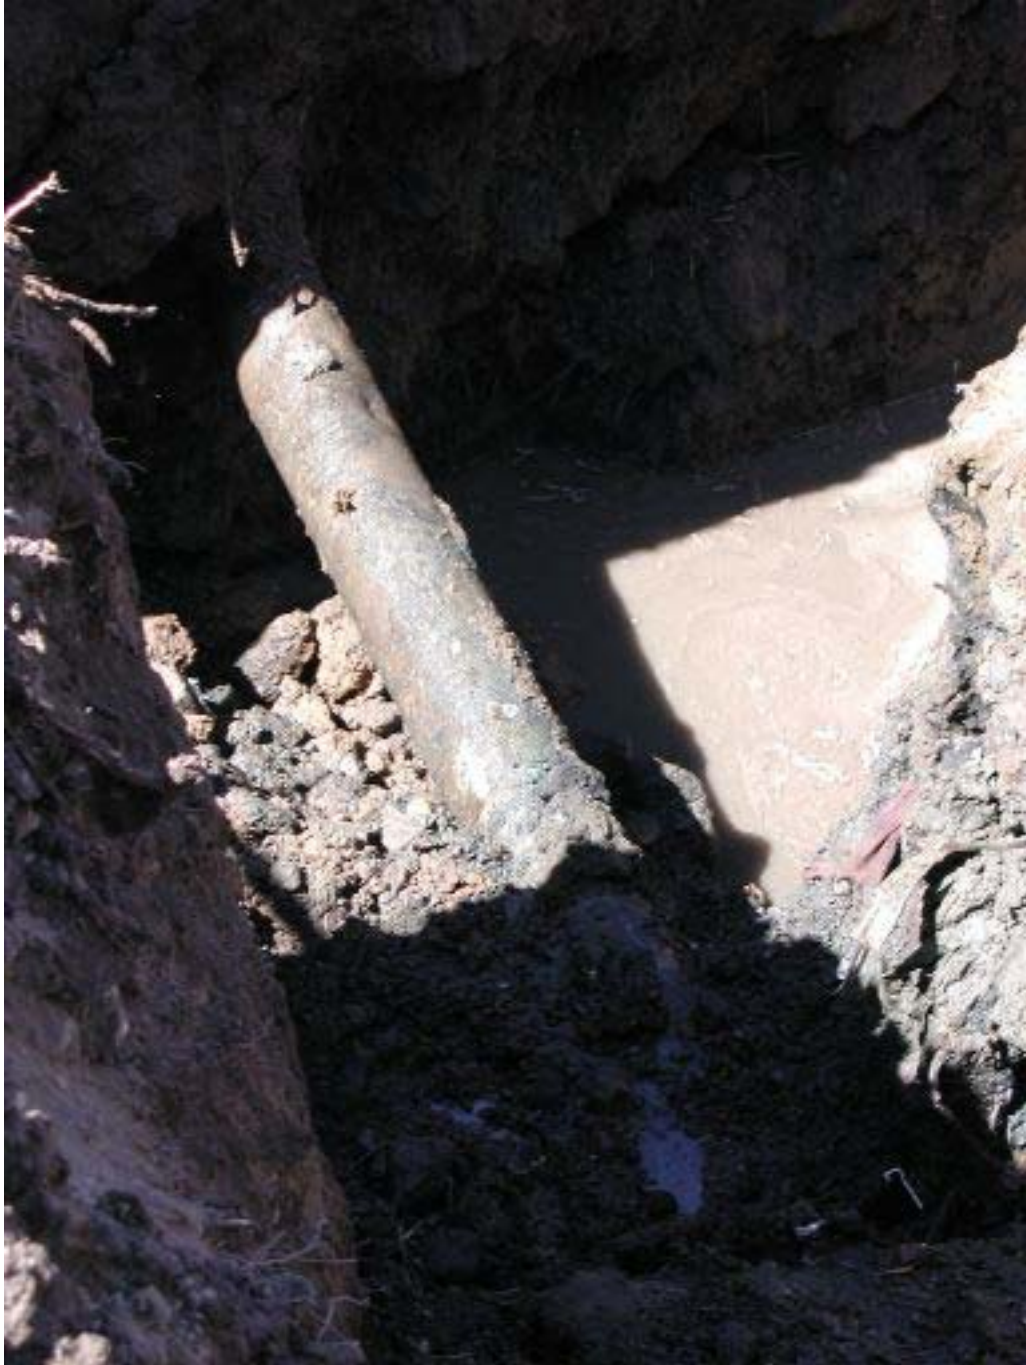
Photograph 4. Ten-inch steel pipe discovered at STA 14+65. Approximately 10 feet deep.

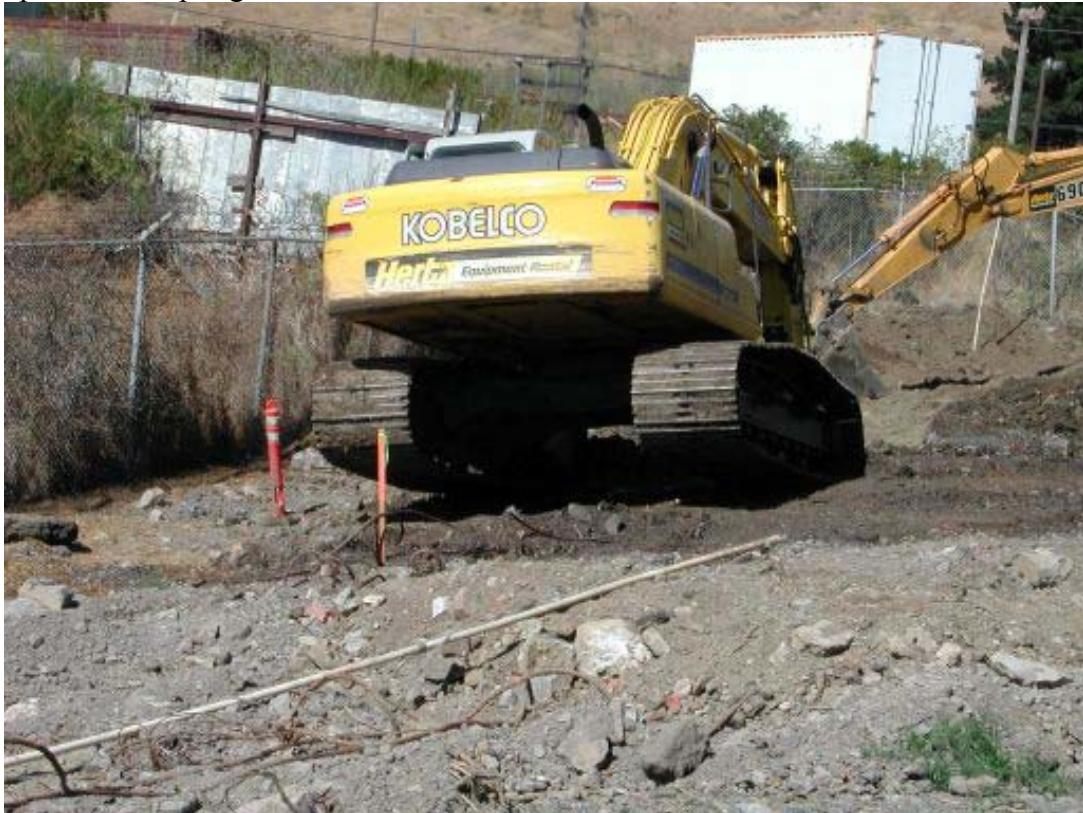
Photograph 5. Attempting to remove ten-inch steel line with excavator.

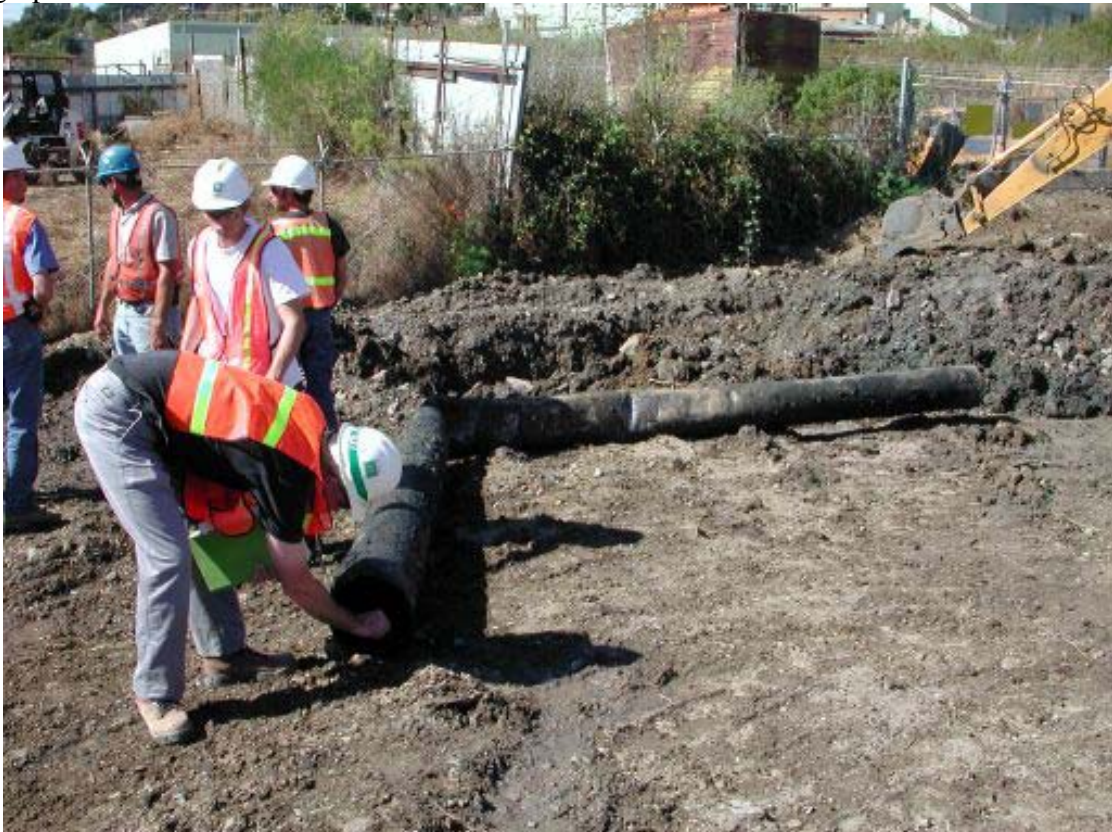
Photograph 6. Ten-inch steel line after removal.
